# Proxy-Arp considered harmful

2011-10-11 **ENOG2**

The 2011-08-13 incident:

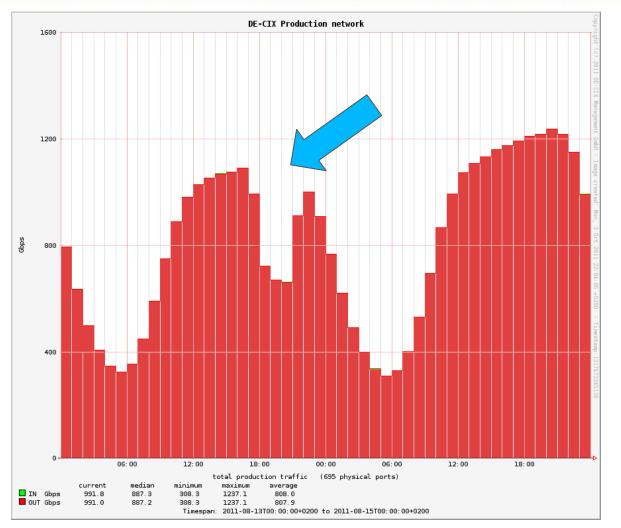
It was a Saturday.
It was peak time.
It took 3.5 hours to fix

145 customers affected Up to 45% traffic loss

Regular proactive checks to identify proxy ARP

- Vendor implementation: disable default proxy ARP
- Use of dynamic ARP inspection with static bindings
