# Proxy-Arp considered harmful

2011-10-11 **ENOG2**

The 2011-08-13 incident:

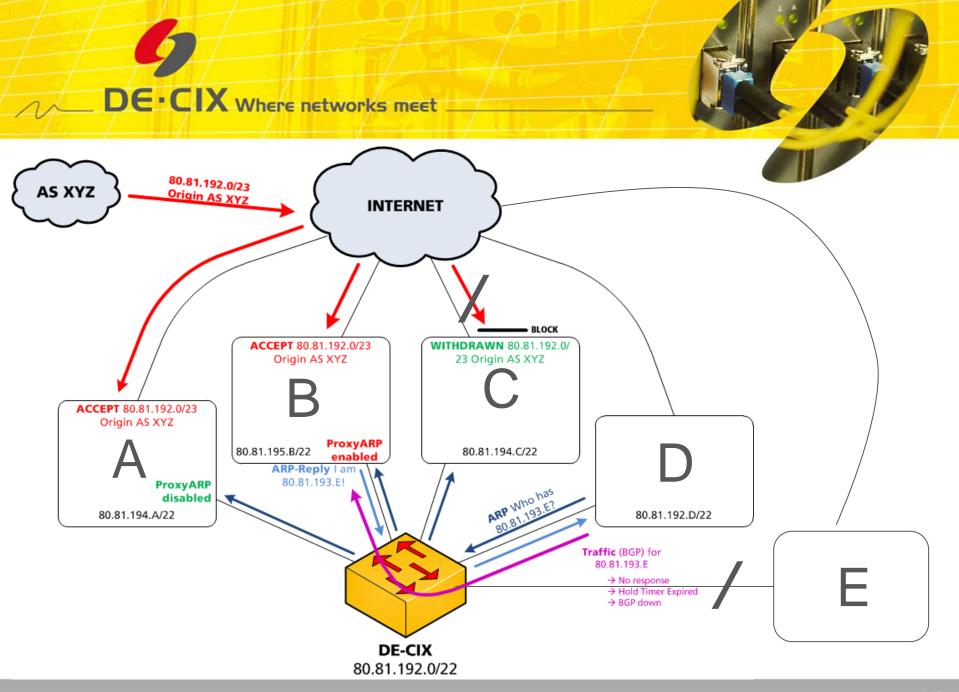
#### DE-CIX Where networks meet 80.81.192.0/23 Origin AS XYZ **INTERNET** BLOCK WITHDRAWN 80.81.192.0/ ACCEPT 80.81.192.0/23 Origin AS XYZ 23 Origin AS XYZ **ACCEPT** 80.81.192.0/23 Origin AS XYZ **ProxyARP** 80.81.195.B/22 80.81.194.C/22 enabled ARP-Reply I am 80.81.193.E! **ProxyARP** ARP Who has 80.81.193.E? disabled 80.81.194.A/22 80.81.192.D/22 **DE-CIX** 80.81.192.0/22

It was a Saturday.
It was peak time.
It took 3.5 hours to fix

145 customers affected Up to 45% traffic loss

Regular proactive checks to identify proxy ARP

- Vendor implementation: disable default proxy ARP
- Use of dynamic ARP inspection with static bindings
